# RESERVE STUDY

## WOODWINDS CONDOMINIUM

**Reston, Virginia**

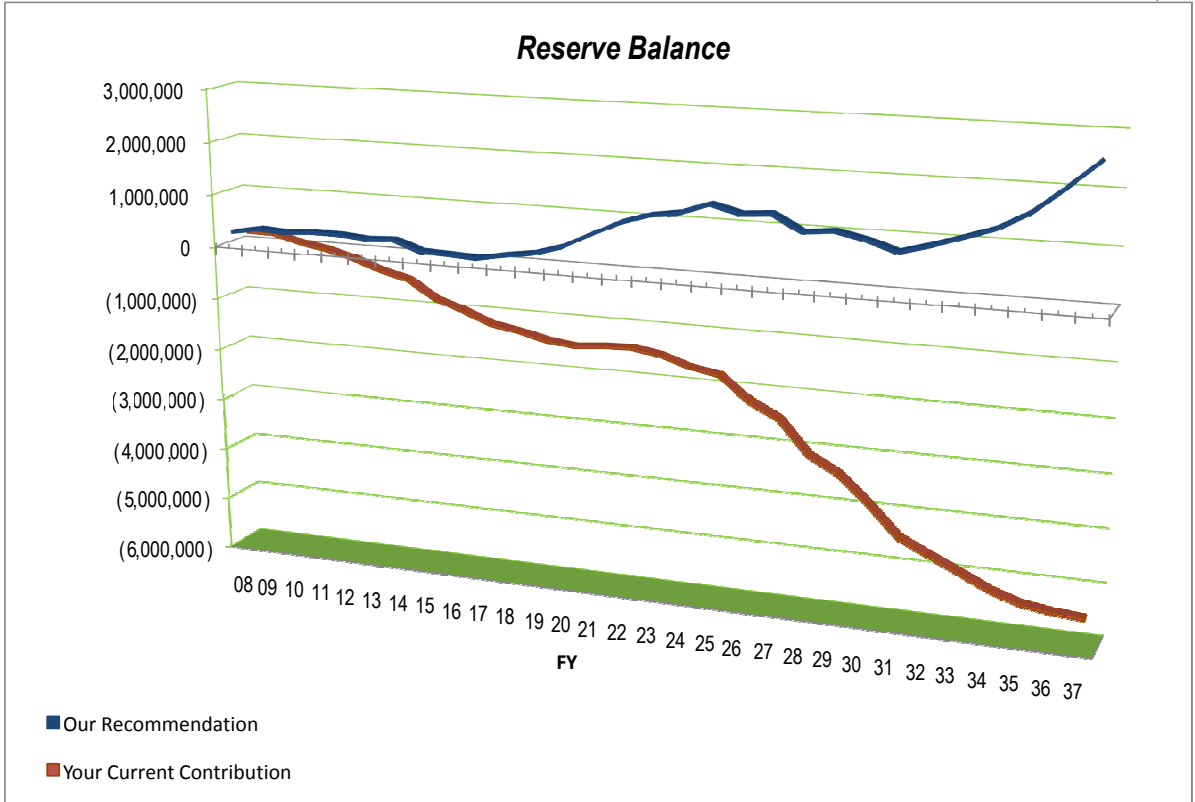
#### SUMMARY

30-Year Annual Average =	\$317,900	\$165,500
30-Year Annual Average per Owner =	\$2,208	\$1,149
Minimum Balance over 30-Years =	\$128,600	(\$5,599,400)
Minimum Balance % =	6%	-245%

- Our analysis of your current contribution to the reserves indicates it will need to be increased if the reserve needs of the property are to be met. See 30-Year Cash Flow Projection chart, column 12, for projected contributions needed to support the reserves.
- During our inspection we noted that the exterior wood and metal are in need of paint. Paint protects these surfaces and minimizes the amount of deterioration they are exposed to. Also, pavement useful life could be extended with preventive maintenance. There are many open cracks in the asphalt.
- In preparing this study **PM+** compared the contributions needed to support both the Cash Flow Pooling and Component methods. Our analysis concluded the cash flow pooling method required the least contribution; therefore, this study is submitted using this method.

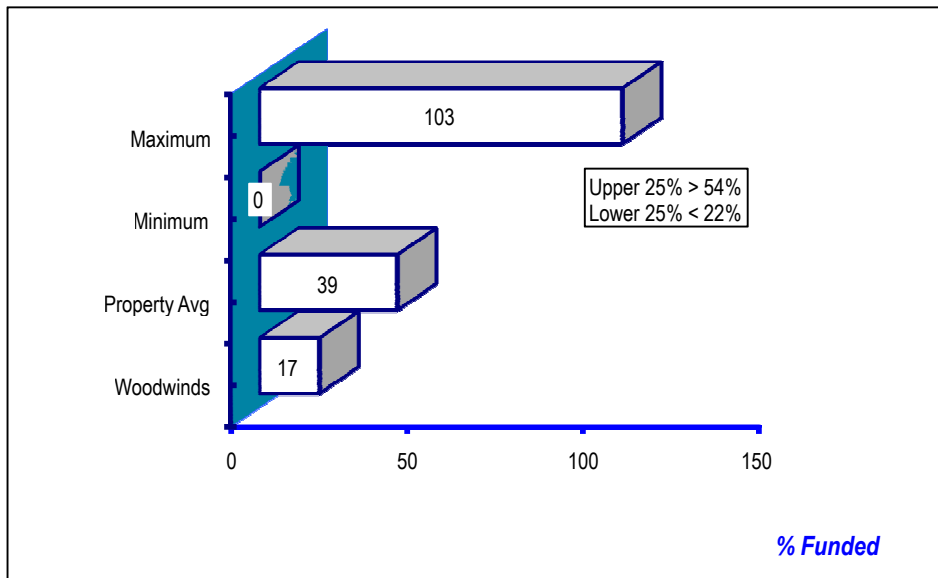
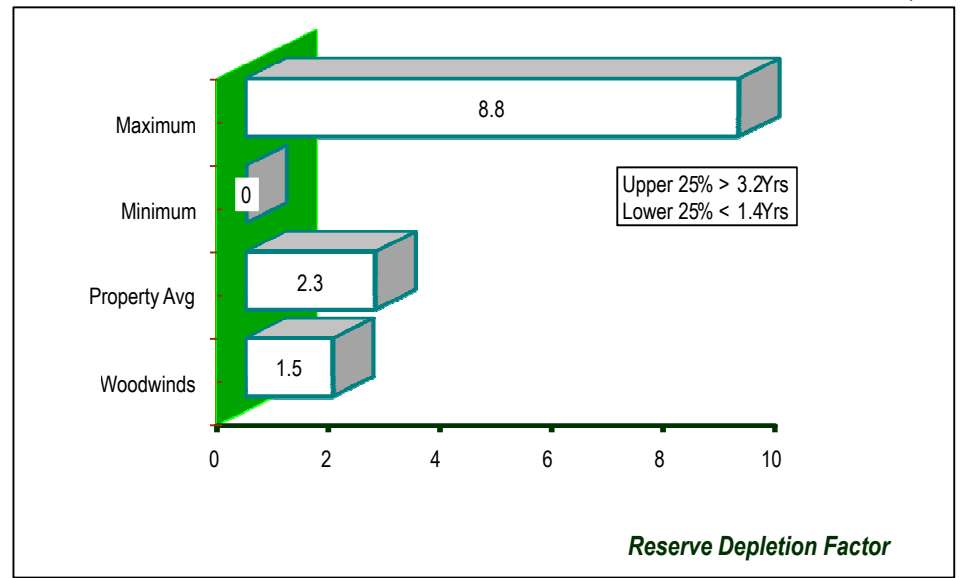
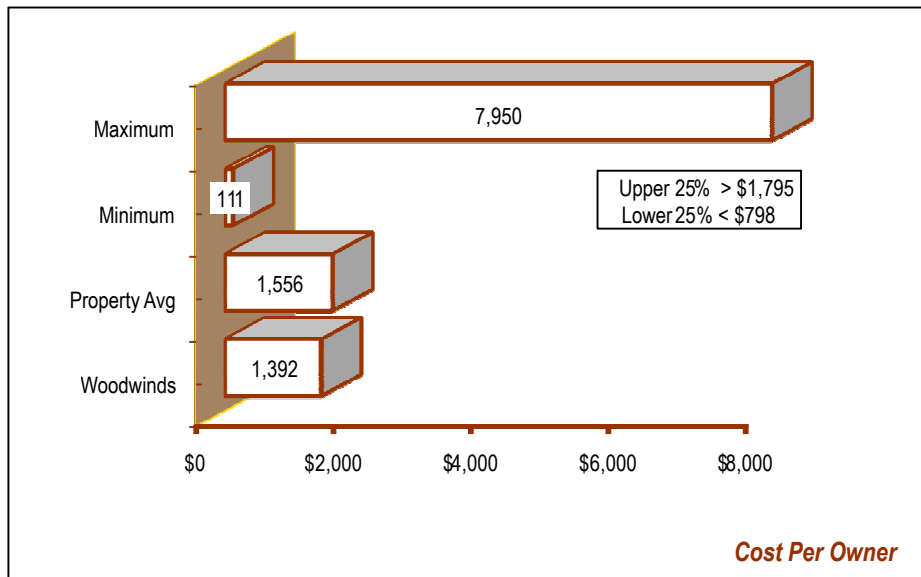
**PROPERTY COMPARISON**  
 Sample Size = 100 Condo's/Coop's

This comparison only compares the first study year to other properties.
